Research Problem Review 79-5

# TACFIRE OT 056 HUMAN FACTORS EVALUATION

ARI FIELD UNIT AT FORT HOOD, TEXAS

March 1979

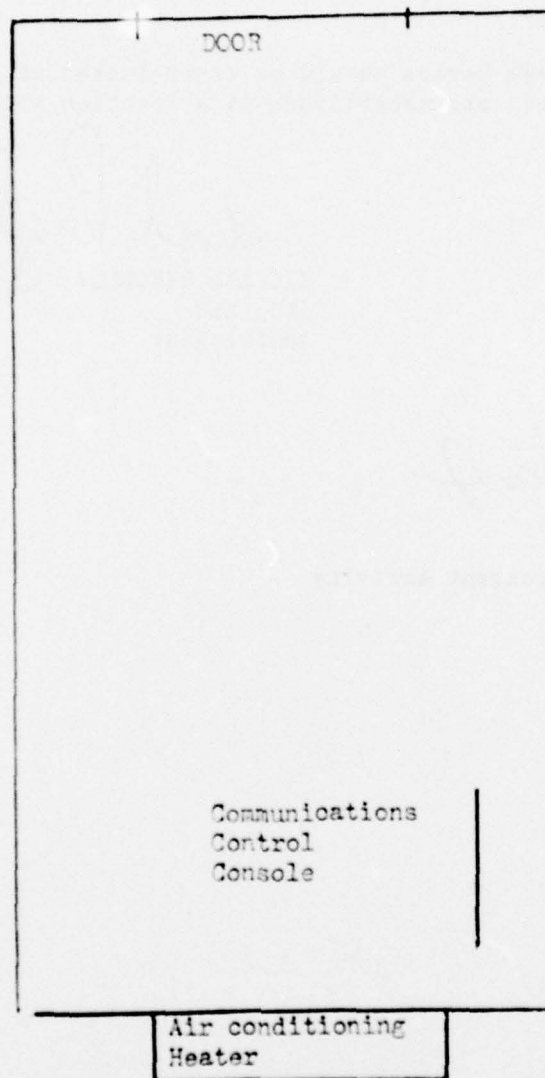
Appendix I Drawing D  
Computer Shelter

Test Condition	1	2	3	4
Operator's Position	73	77	63	79 dB(A)
Octave Band				
125 Hz	74	79	61	80 dB
250 Hz	72	74	62	79
500 Hz	69	72	62	76
1000 Hz	67	72	58	76
2000 Hz	62	63	59	65
4000 Hz	54	59	45	60
8000 Hz	52	54	41	56

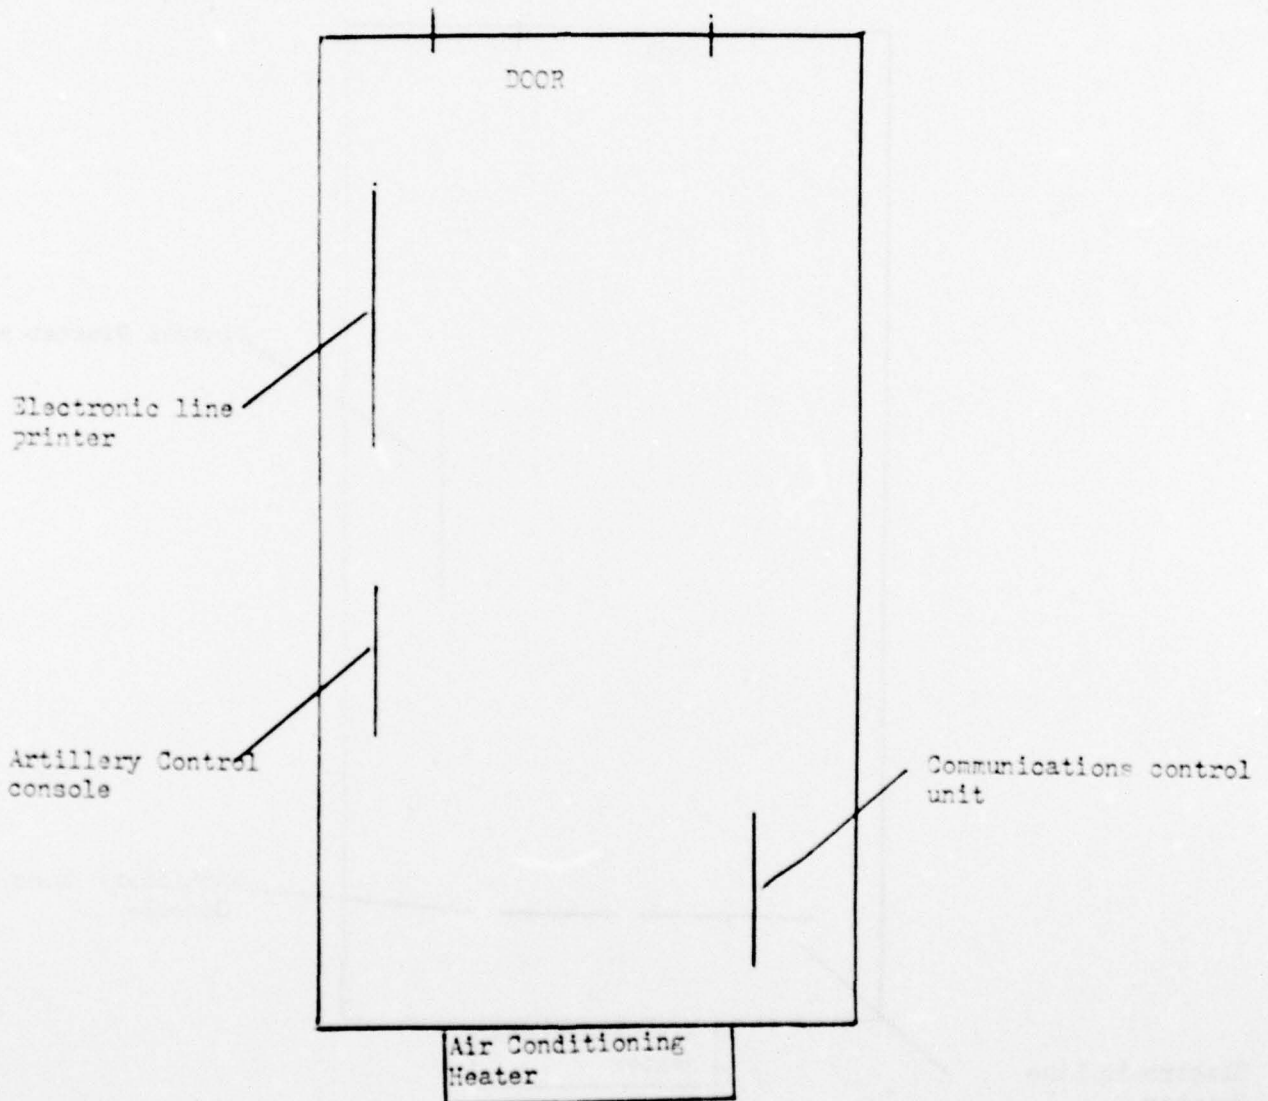
Appendix I Drawing A  
Battalion Shelter

Test Condition	1	2	3	4
Operator's Position	70	74	74	65 dB(A)
Octave Band				
125 Hz	72	74	73	72 dB
250 Hz	66	79	78	65
500 Hz	63	72	73	62
1000 Hz	67	67	65	61
2000 Hz	60	62	64	58
4000 Hz	66	61	61	58
8000 Hz	46	51	55	44

Test Condition	1	2	3	4
Operator's Position	73	74	76	65 dB(A)
Octave Band				
125 Hz	73	78	76	70 dB
250 Hz	70	80	80	66
500 Hz	65	76	73	67
1000 Hz	59	66	68	58
2000 Hz	66	64	64	59
4000 Hz	57	59	61	57
8000 Hz	45	56	63	43

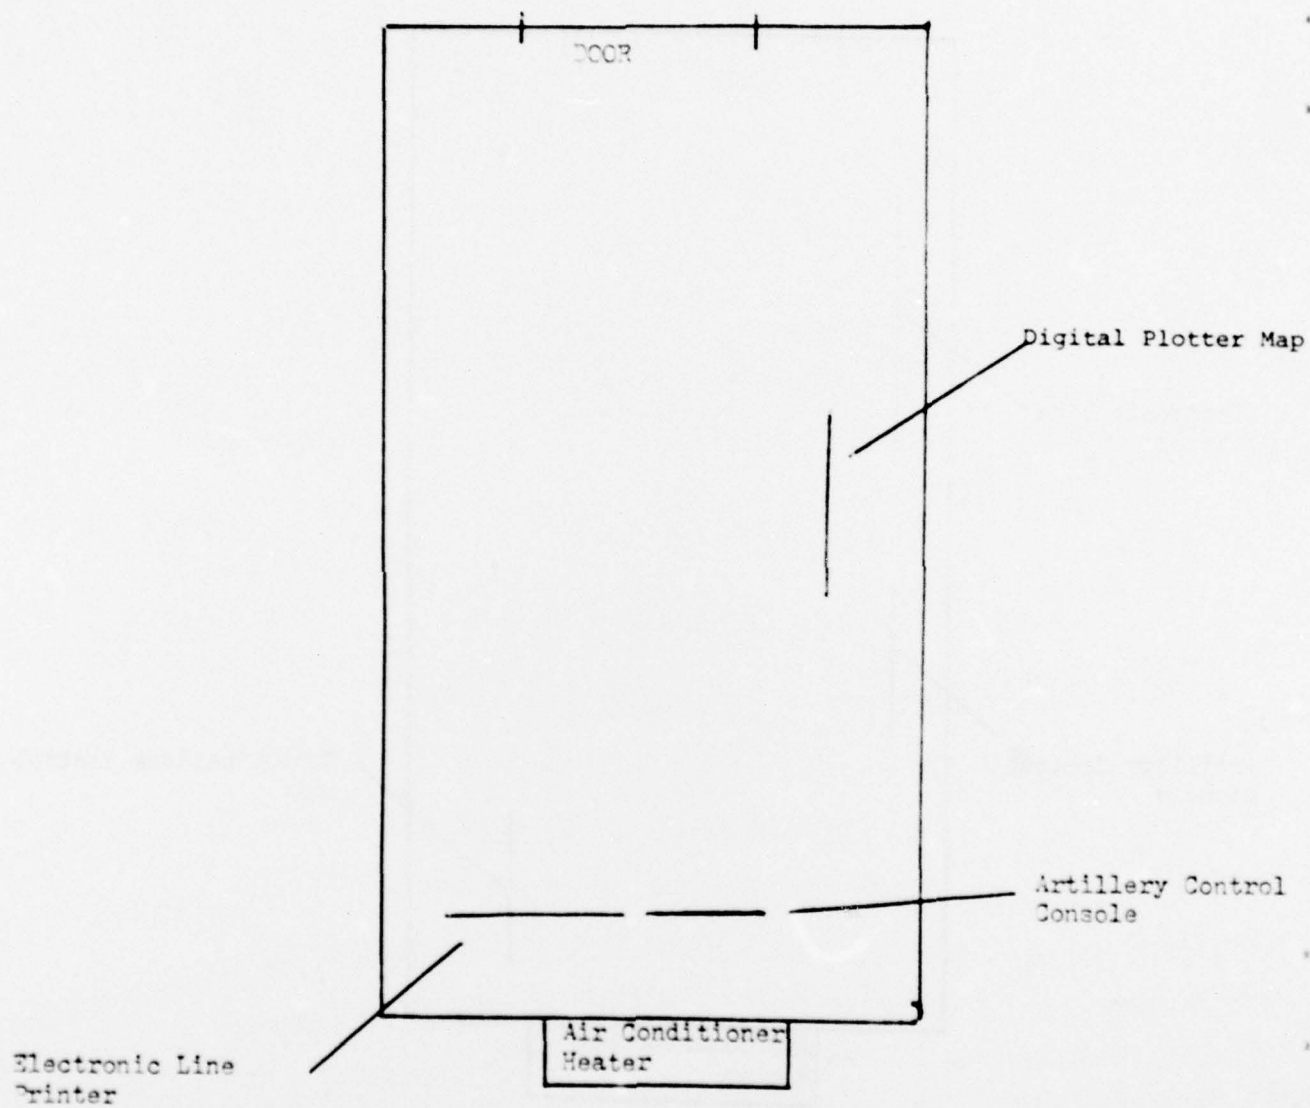
Appendix I Drawing B  
Display Shelter

Test Condition	1	2	3	4
Operator's Position	72	76	80	67 dB(A)
Octave Band				
125 Hz	73	75	79	66 dB
250 Hz	68	80	80	64
500 Hz	62	73	77	63
1000 Hz	66	69	76	70
2000 Hz	62	63	73	58
4000 Hz	64	64	68	55
8000 Hz	53	58	65	47

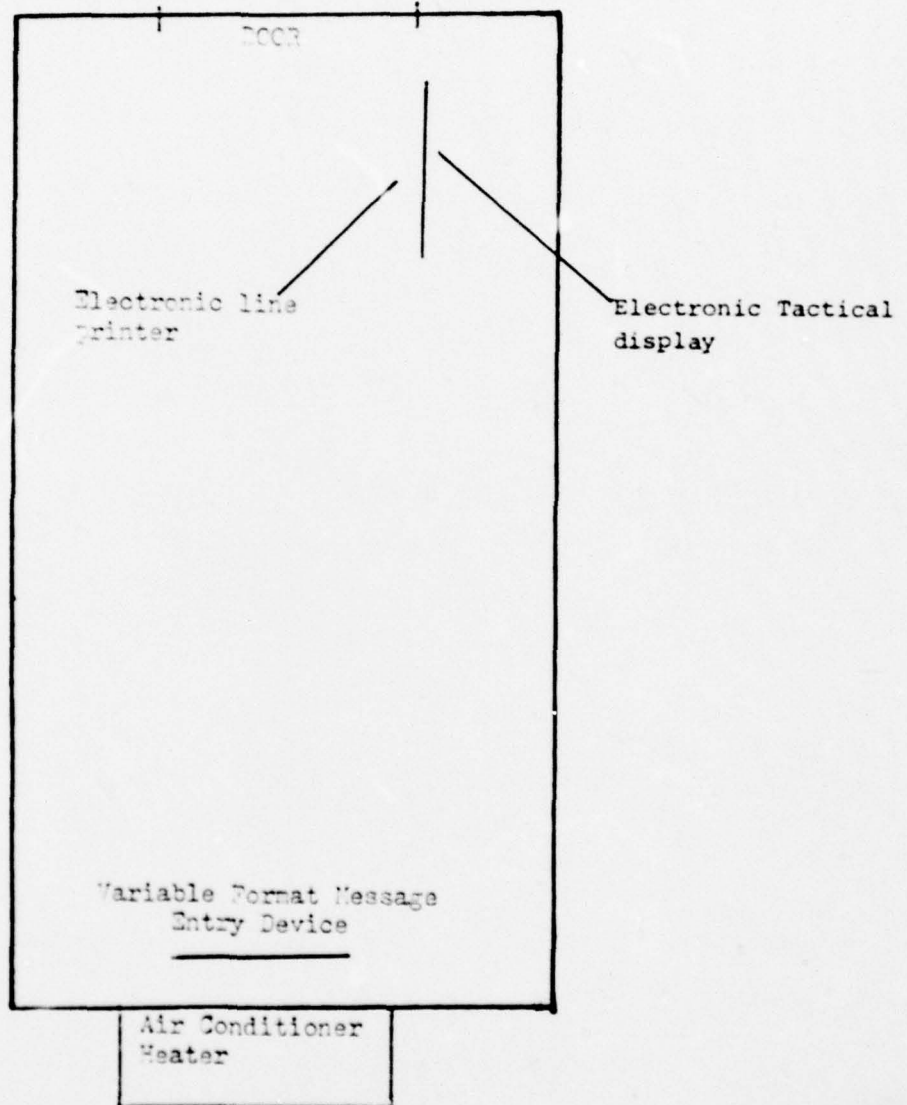
Appendix I Drawing C  
Counterfire Van

Test Condition	1	2	3	4
Operator's Position	72	77	76	67 dB(A)
Octave Band				
125 Hz	56	54	56	58 dB
250 Hz	63	65	61	61
500 Hz	64	68	63	63
1000 Hz	68	71	70	68
2000 Hz	71	75	73	71
4000 Hz	65	63	64	61
8000 Hz	61	59	57	54
